Asbestos and Lead-Based Paint Inspection

3760 & 3678 Park Avenue
Doraville, DeKalb County, Georgia

May 2018

Prepared for:
City of Doraville Downtown Development Authority
EPA Cooperative Agreement BF-00D48116-0

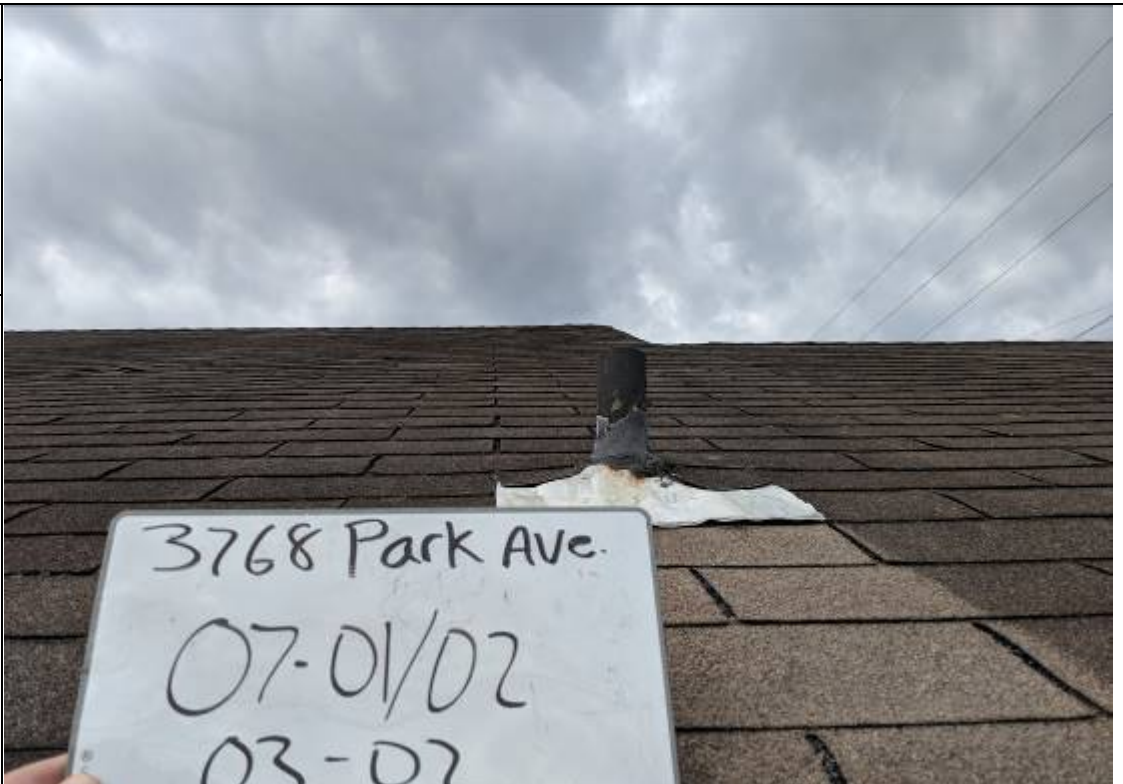
Photo No.
2

The penetration pipe mastic located at 3760 Park Avenue consisted of approximately 75 linear feet and at 3768 Park Avenue approximately 25 linear feet. This material is located on a pipes extending from the roof of each building, and appeared to be in good condition. The penetration pipe mastic is considered a non-friable miscellaneous Category I material.

Sample 07-01/02 and
confirmed ACM black
penetration pipe mastic on
the roof of commercial
building at 3768 Park
Avenue

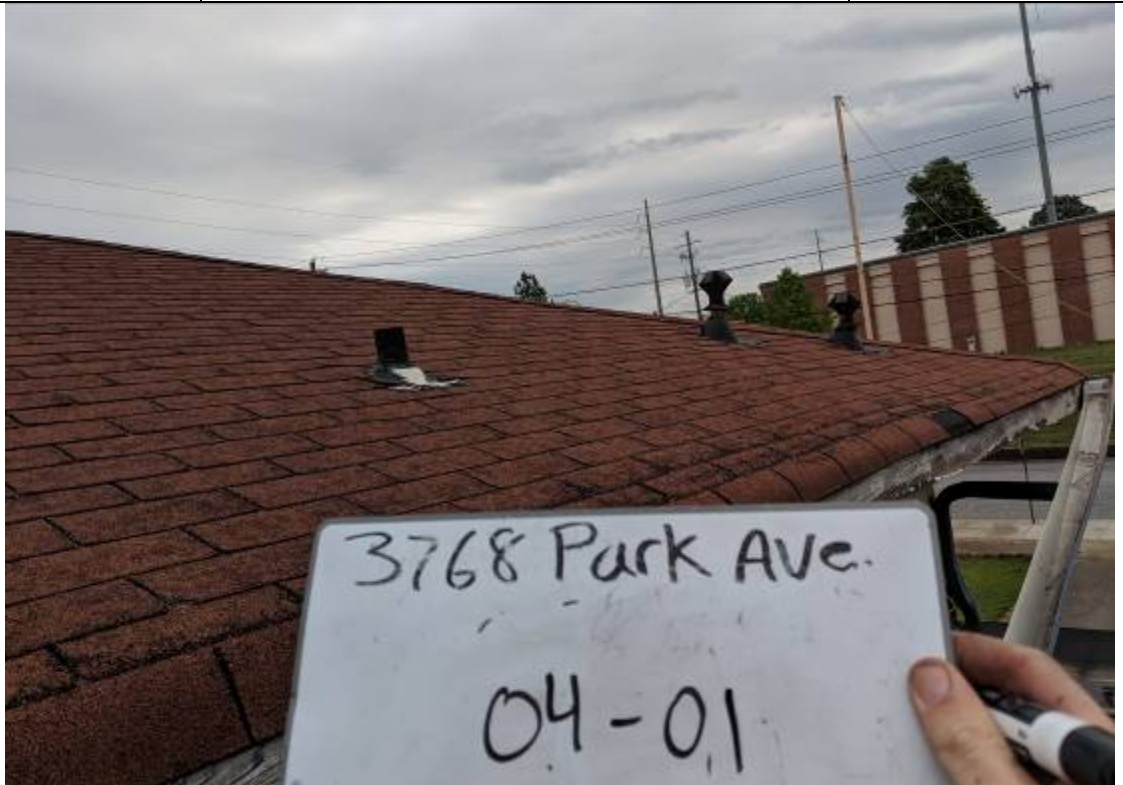
Sample 04-01 of confirmed
ACM black penetration pipe
mastic on roof of 3760 Park
Avenue

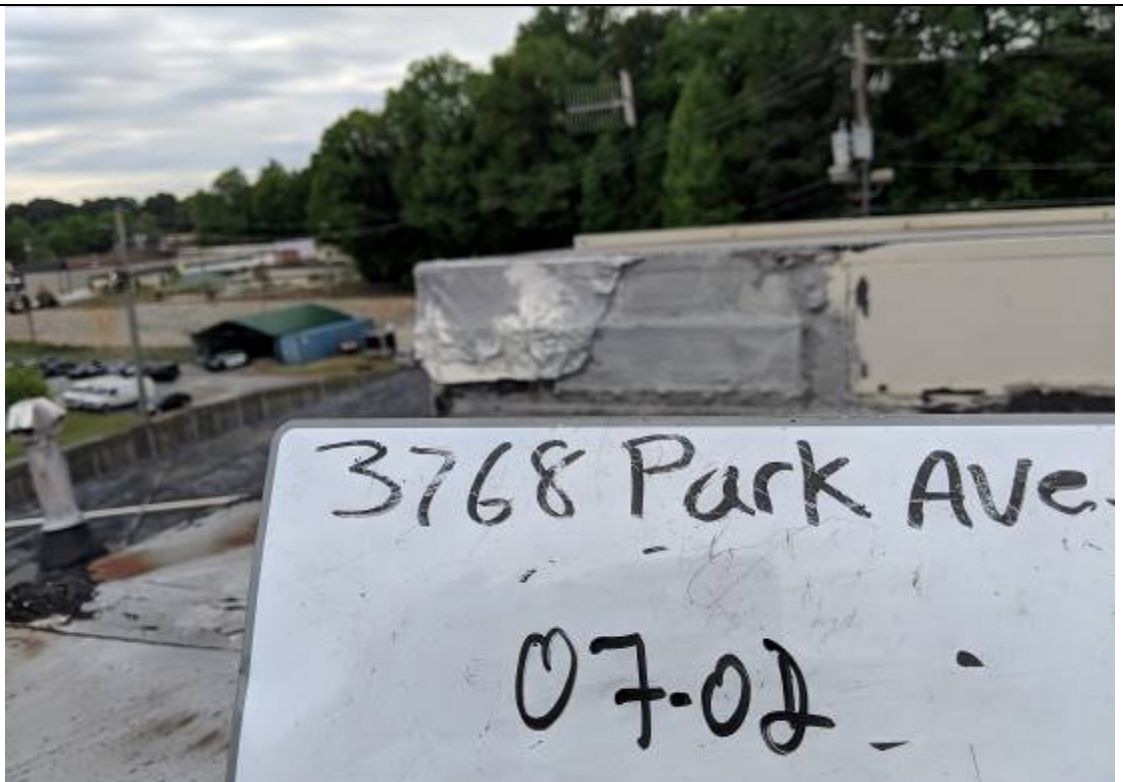
Photo No.
4

The silver HVAC mastic is located along the HVAC handling units located on the lower roof of 3760 Park Avenue and consists of approximately 200 square feet. This material appears to be in good condition, and is considered a non-friable miscellaneous Category I material.

Sample 07-02 of confirmed
ACM silver HVAC mastic
on roof of 3760 Park
Avenue

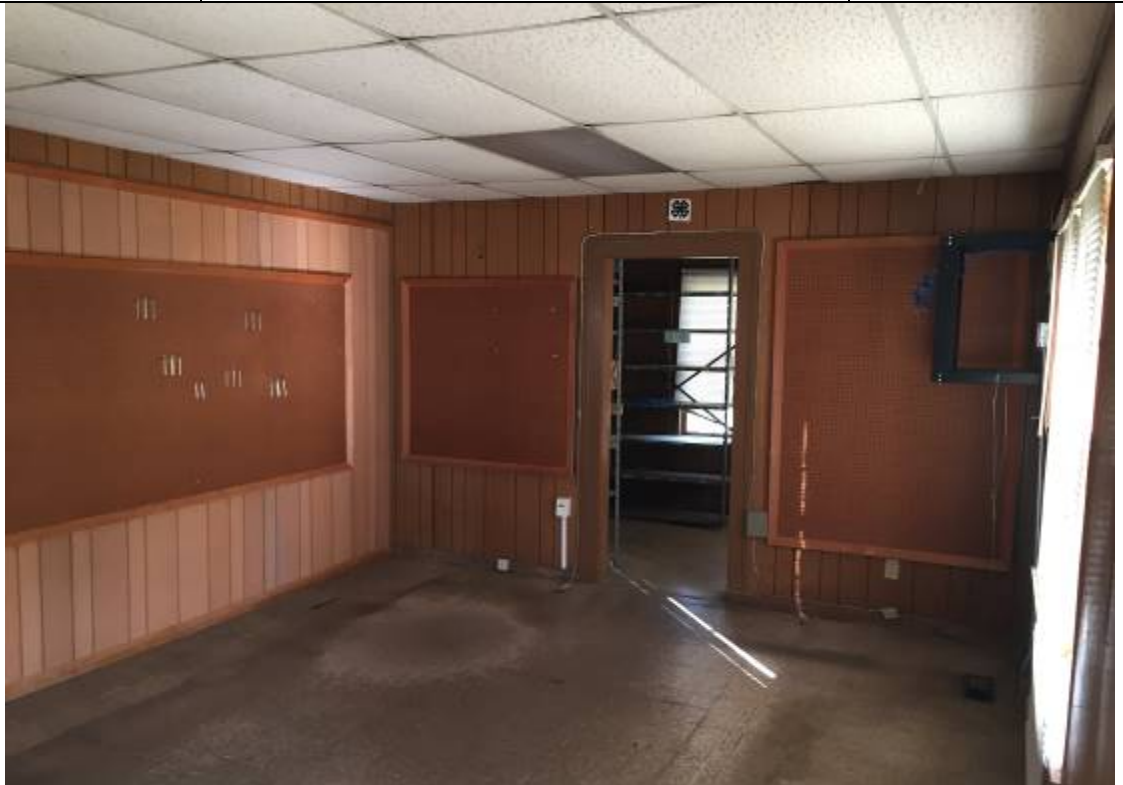
Interior of 3678 Stewart Road with confirmed ACM floor tile and associated mastic.

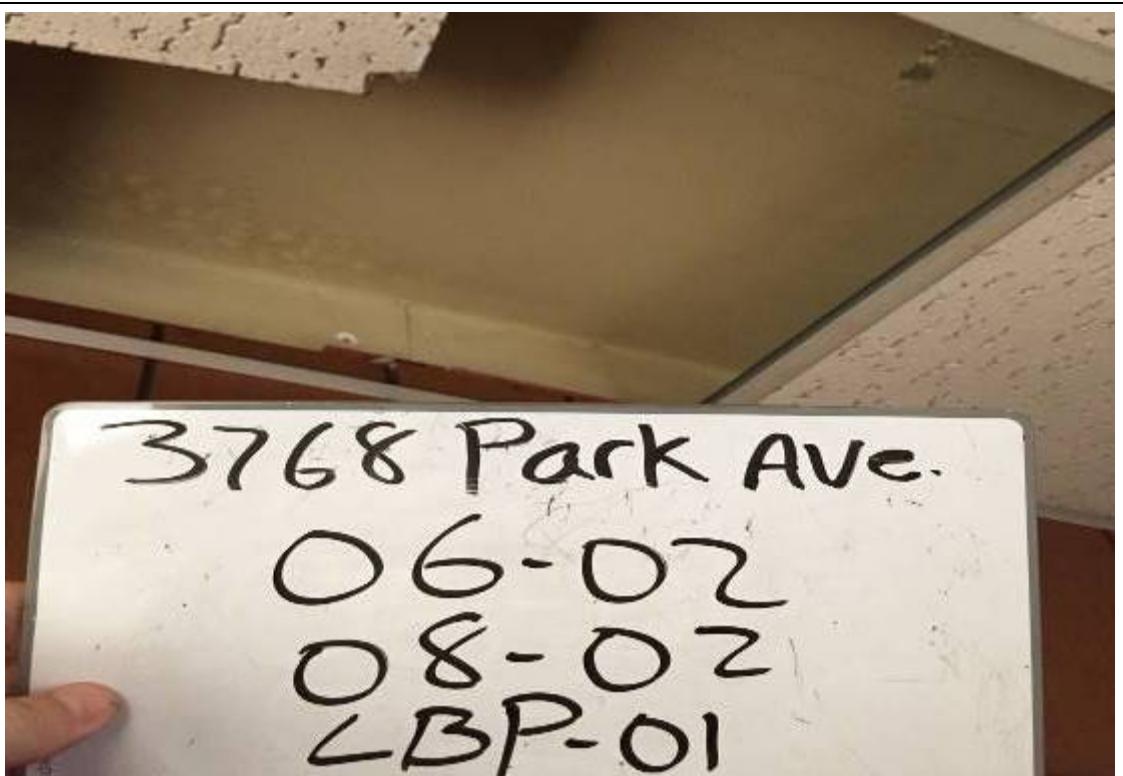
Photo No.
6

Samples 06-02, 08-02, and LBP-01 in the storage room of 3768 Park Avenue. Confirmed LBP on textured plaster ceiling.

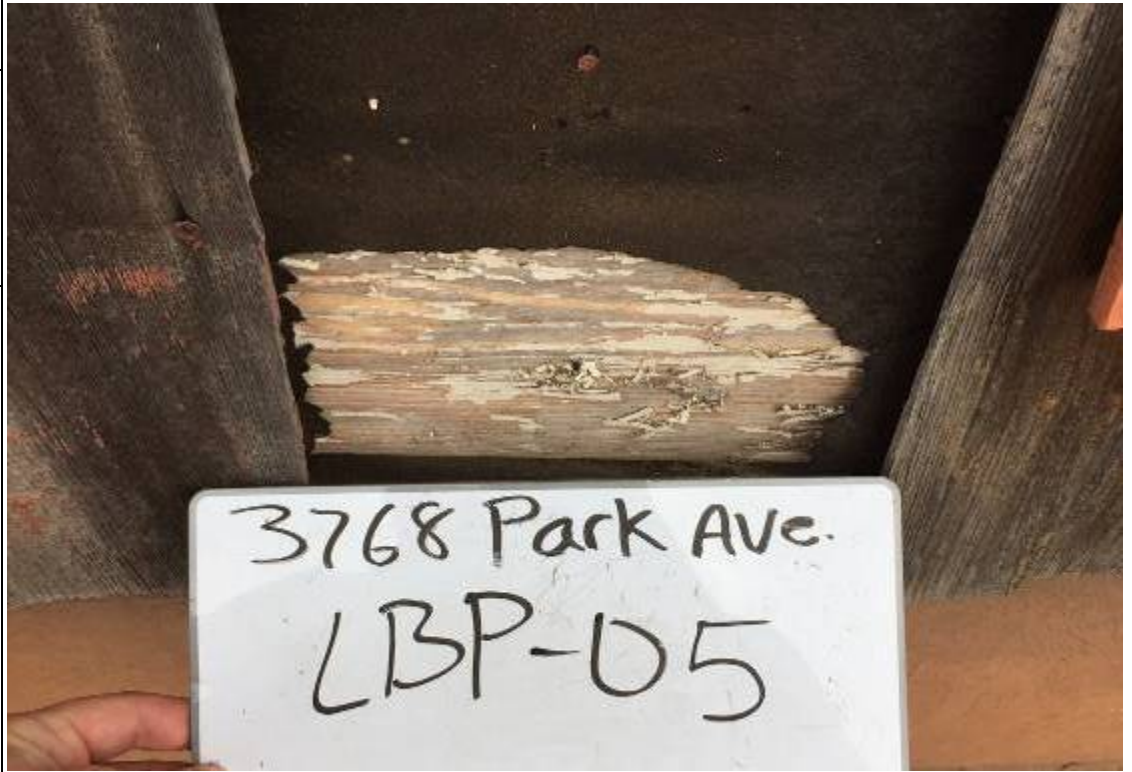
The identified paint appeared to be intact with the exception of the white paint behind the exterior siding and felt. This paint is in poor condition with moderate deterioration; however, this material appears to be stabilized behind the exterior siding and felt.

Sample LBP-05 of confirmed LBP of white paint behind siding field on exterior of 3768 Park Avenue.

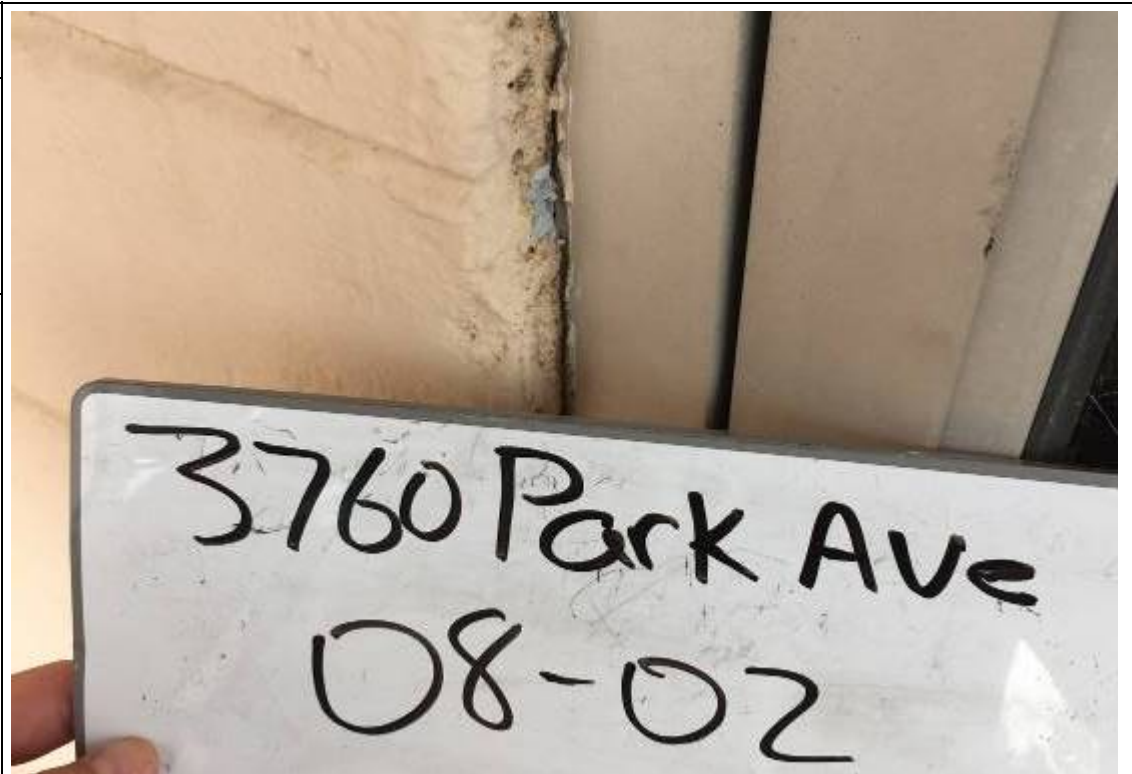
Photo No.
8

The grey exterior door caulk is located along three front doors of 3760 Park Avenue and consists of approximately 100 linear feet. This material appears to be in good condition, and is considered a non-friable miscellaneous Category II material.

Sample 08-02 of confirmed ACM grey door caulk on the exterior of 3760 Park Avenue.

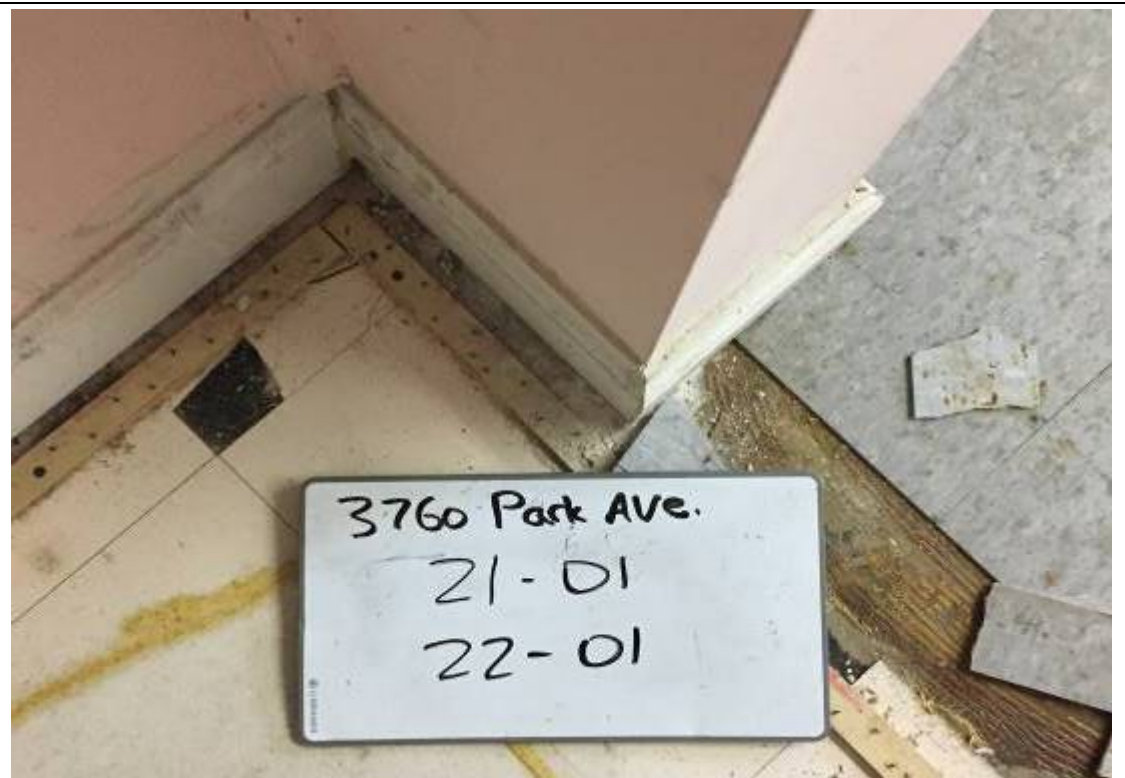
Photo No.
10

Samples 21-01 and 22-01 of confirmed ACM floor tile and associated black mastic in Room 19 and adjacent hallway in 3760 Park Avenue.

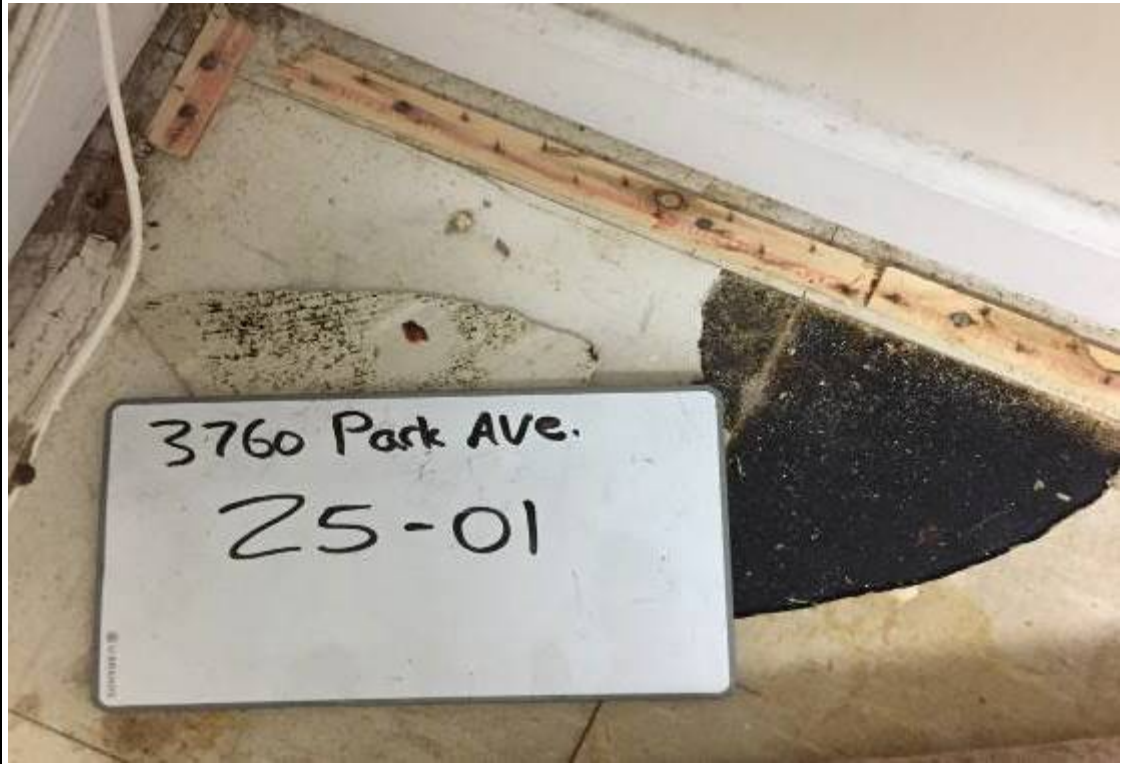
Sample 25-01 of confirmed floor tile and associated mastic in 2nd floor of 3760 Park Avenue.

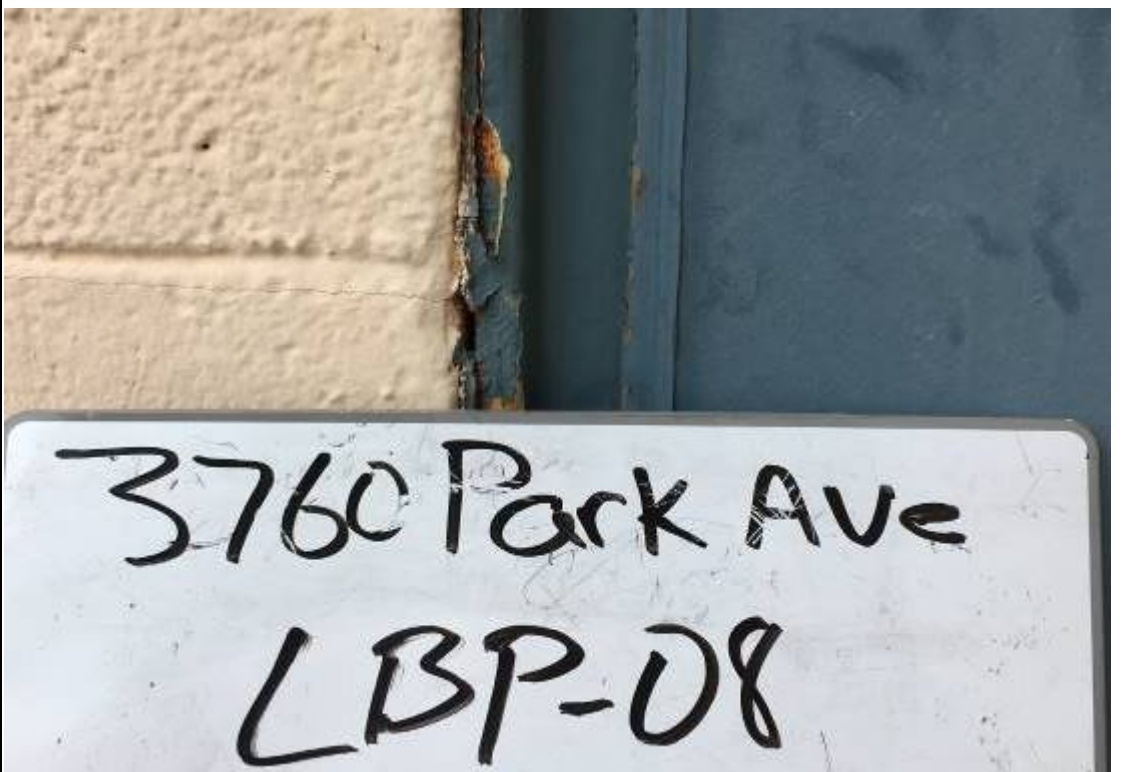
Photo No.
12

Sample LBP-08 of confirmed LBP on blue doors on exterior of 3760 Park Avenue.
